# A Study on Infrastructural Facilities for Differently Abled in Banks

**Objective:** The present study was taken up to explore the availability of infrastructural facilities for the differently abled and problems faced by them in banks.

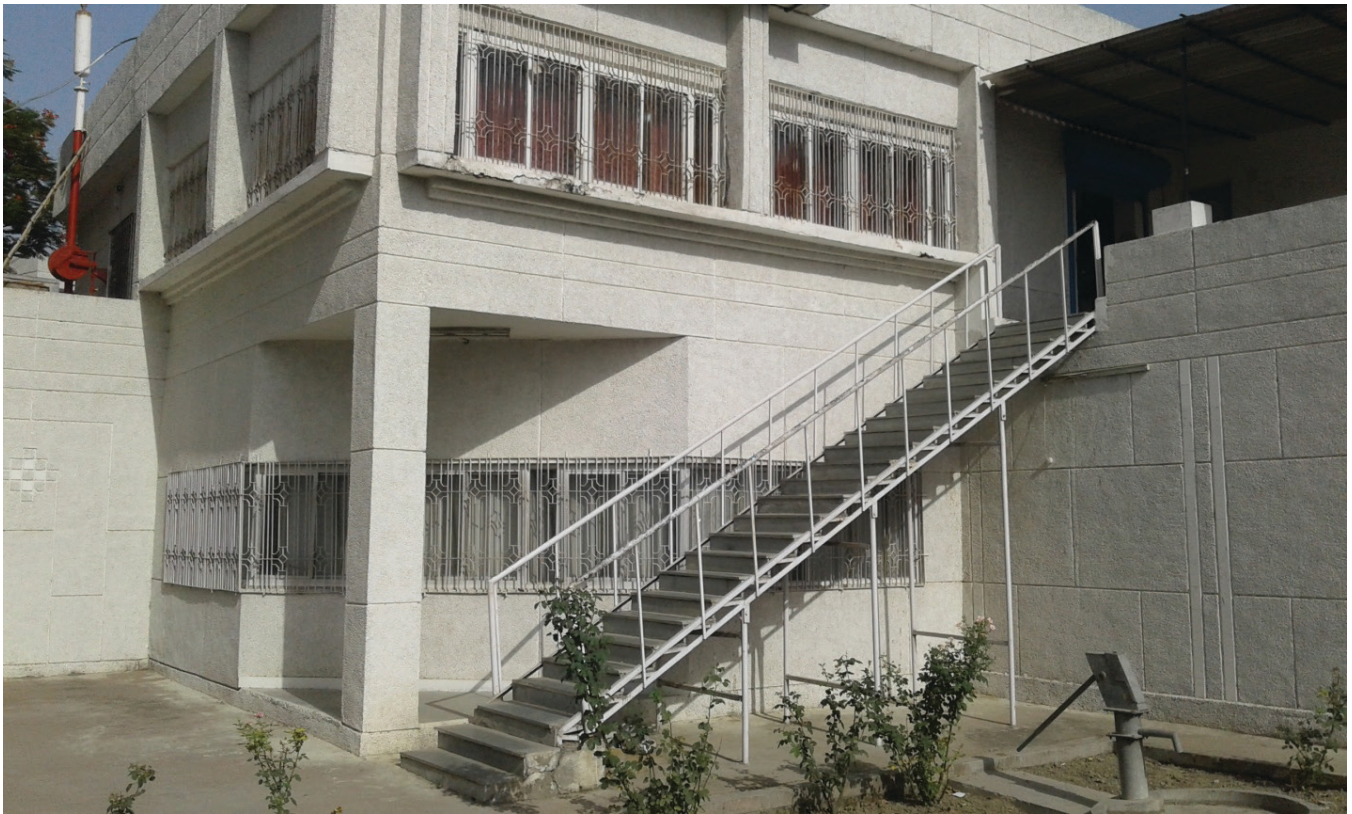
**Figure 1:** Prospective view of the bank where there is no ramp facility.
